# THE USUAL SUSPECTS

## Irregular Trailer Tire Conditions

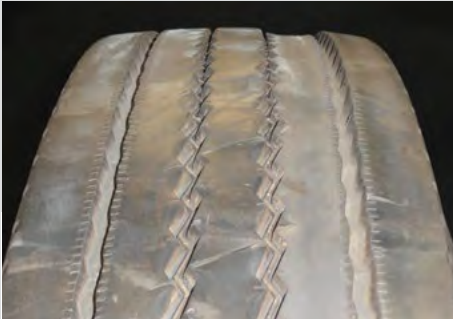
**Depression Wear**  
(Intermediate)

| Appearance | One or more interior ribs (not center) worn below adjacent ribs around the tire's circumference. |
| Probable Cause | Worn suspension components, mismatched dual diameter or inflation pressures, under-inflation, improper bearing adjustment. Aggravated by high speed/light loads. |

| Corrective Action | Diagnose mechanical condition and correct. |
| Tire Disposition | Continue to run until pull point, then retread. |

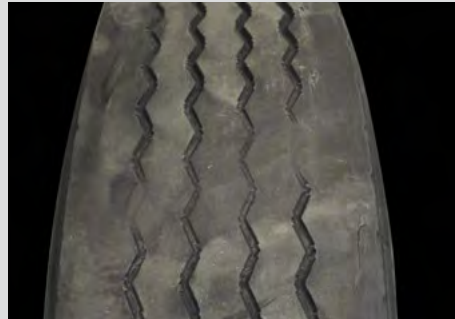
**Diagonal Wear**

| Appearance | Localized flat spots worn diagonally across the tread, often repeating around the tire. |
| Probable Cause | Improper bearing adjustment, misalignment, mismatched dual tire diameter and/or inflation pressure. May start as brake skid. Aggravated by high speed/light loads. |

| Corrective Action | Analyze cause and correct. |
| Tire Disposition | Reverse direction of rotation. If excessive, submit for retreading. |

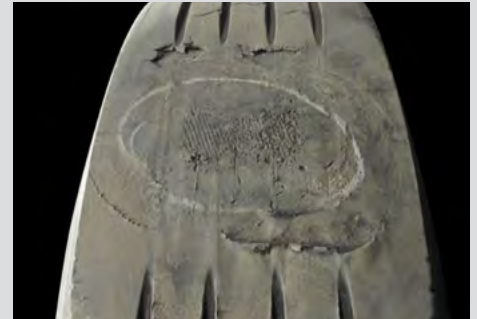
**Brake Skid Damage**

| Appearance | Localized spot of excessive wear across tread face showing abrasion marks. Damage may extend into casing. |
| Probable Cause | New brakes (not worn in), unbalanced brake system, frozen brake lines, driver abuse. |

| Corrective Action | Check brake system. |
| Tire Disposition | May be repaired or retreaded if casing is undamaged; otherwise, scrap. |

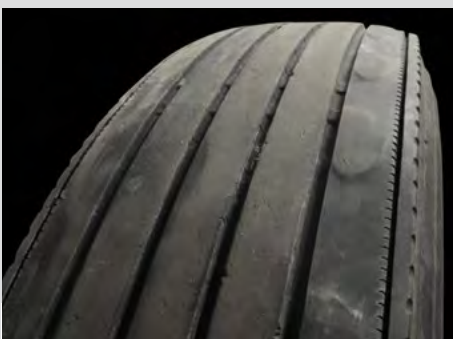
**Depression Wear**  
(Shoulder)

| Appearance | Localized areas of wear in shoulder, generally less than 12" in length. |
| Probable Cause | Improper inflation pressure or tire mismounted on wheel. Can also be caused by some other type of wheel end imbalance. |

| Corrective Action | Review tire and wheel end maintenance practices. |
| Tire Disposition | Continue to run until pull point, then retread. |

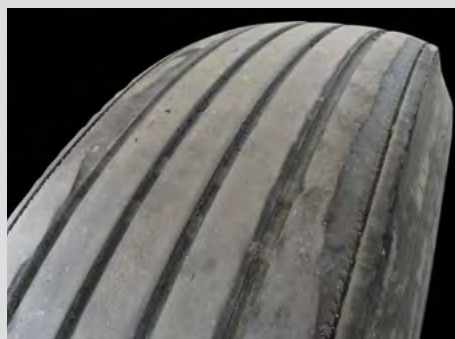
**Shoulder Step Wear**

| Appearance | Tire worn on edge of one shoulder, greater than 12" in circumference. |
| Probable Cause | Excessive camber, misaligned or damaged axle, improper bearing adjustment. |

| Corrective Action | Diagnose misalignment and/or mechanical condition and correct. |
| Tire Disposition | Reverse direction of rotation. If excessive, submit for retreading. |

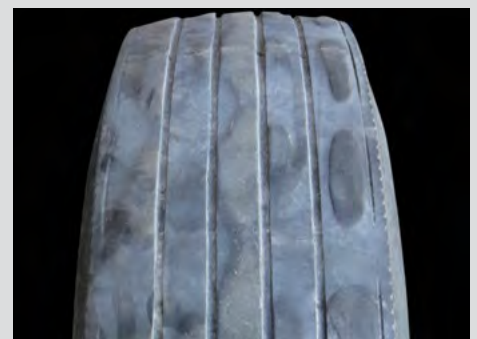
**Cupping / Scallop Wear**

| Appearance | Random areas of fast wear around the tire. Erratic in some instances. |
| Probable Cause | Mismatched inflation pressure or tire diameters in a dual assembly. Aggravated by high speeds/light loads, poorly maintained suspension components. |

| Corrective Action | Check for worn components, inflation pressures and matching tread depths. |
| Tire Disposition | Continue to run until pull point, then retread. |
